Evaluating Management Actions to Promote Salt Marsh Resilience

Rachel W. Jakuba, PhD, Buzzards Bay Coalition
SNEP Symposium, May 18, 2022

Marstons Mills River Headwaters Cranberry Bog Restoration Project

Teaneck Creek Park Habitat Restoration: Regenerative Stormwater Conveyance & Sand Seepage Wetlands

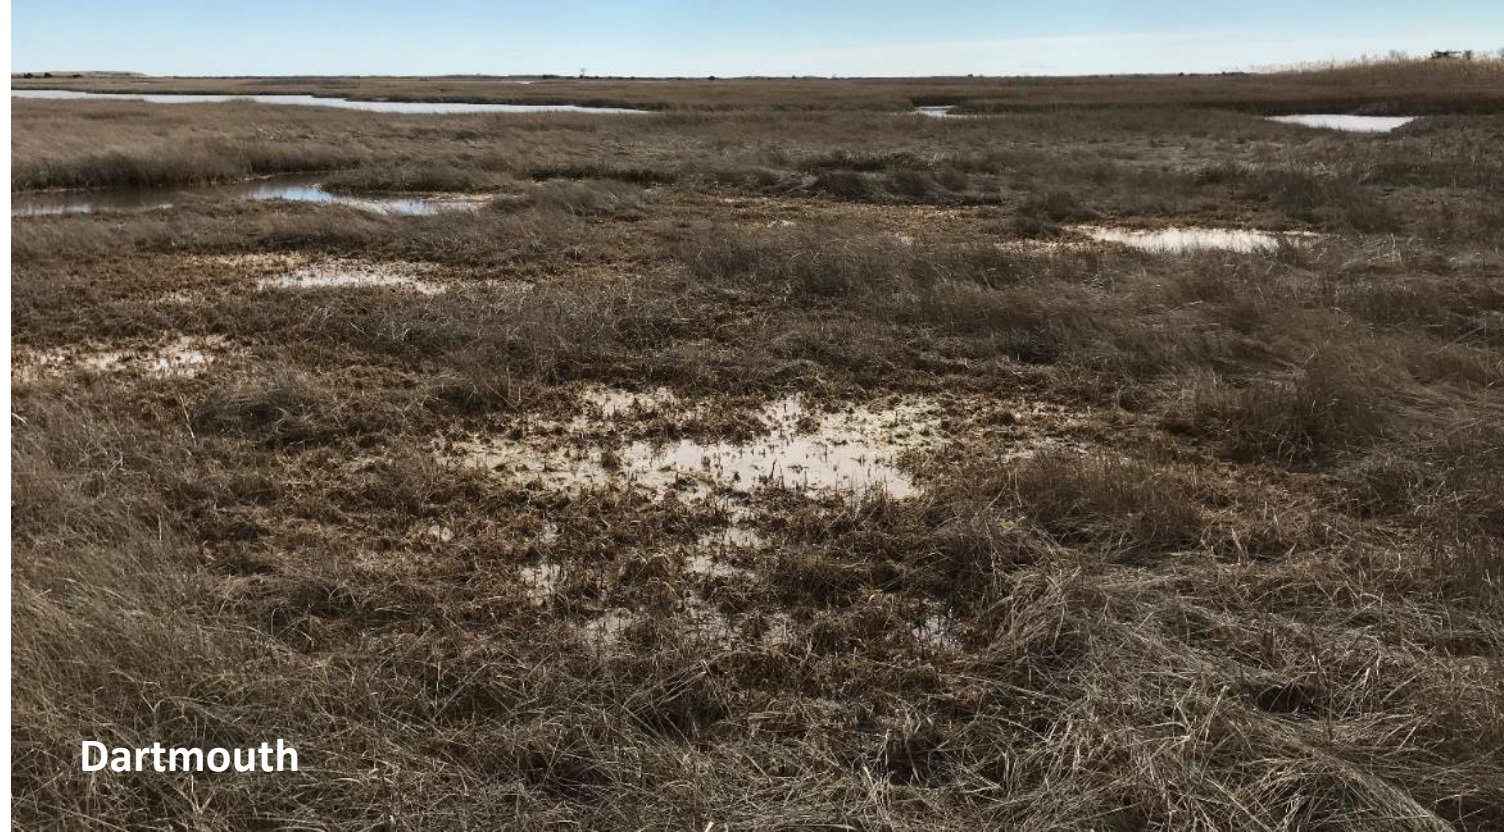
Marsh Loss around Buzzards Bay

If the water stays on the marsh for too long, it drowns the plants. Shallow water areas have the potential to expand outward rapidly, killing vegetation and converting interior marsh platform into open water.

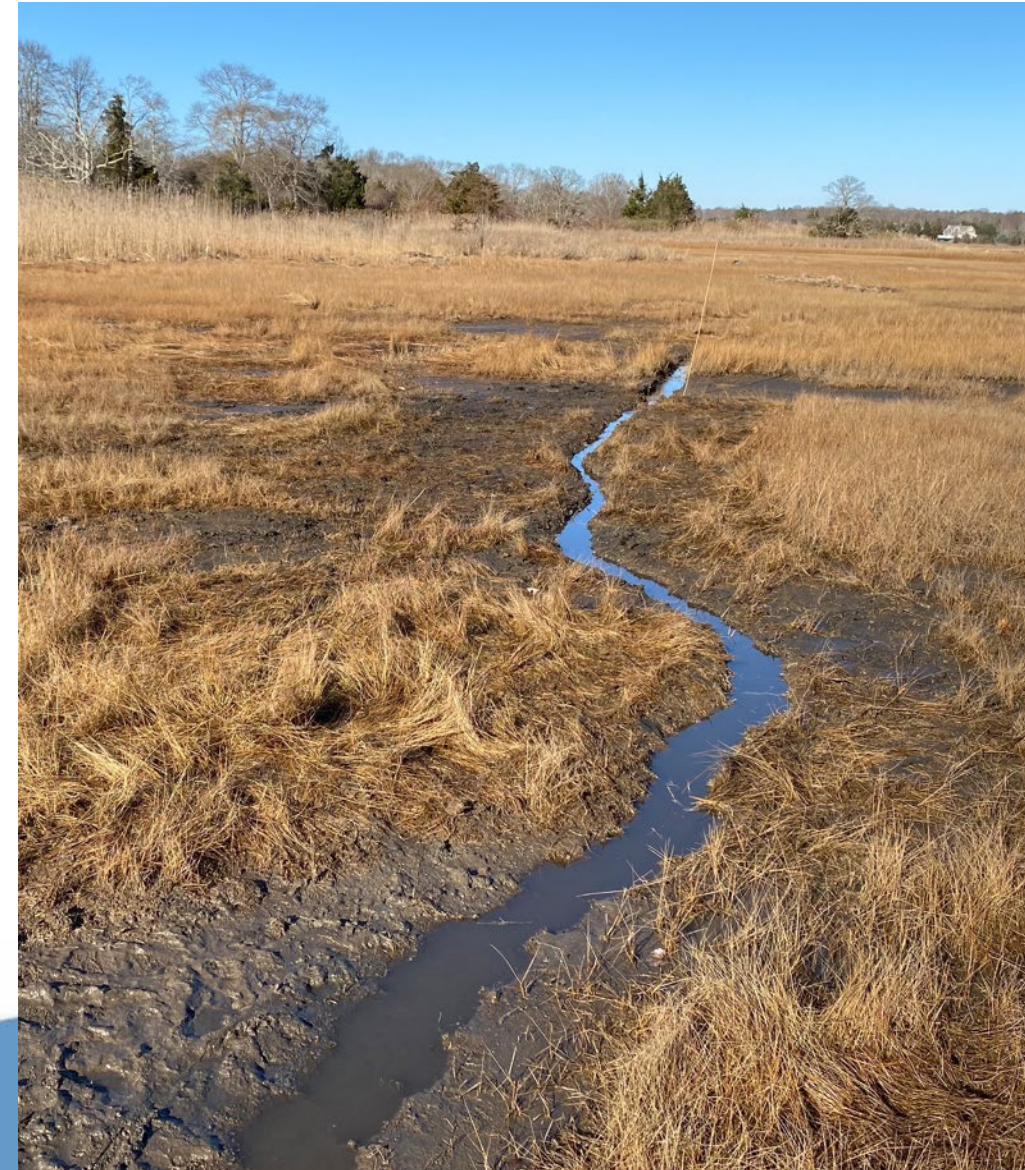
- Runnels are small channels to create tidal connection between shallow water on the marsh surface and a creek or ditch, following topographical low areas or existing flow paths, and draining root zone
- Wenley Ferguson, Save the Bay, RI began piloting runnels for salt marsh adaptation around 2010

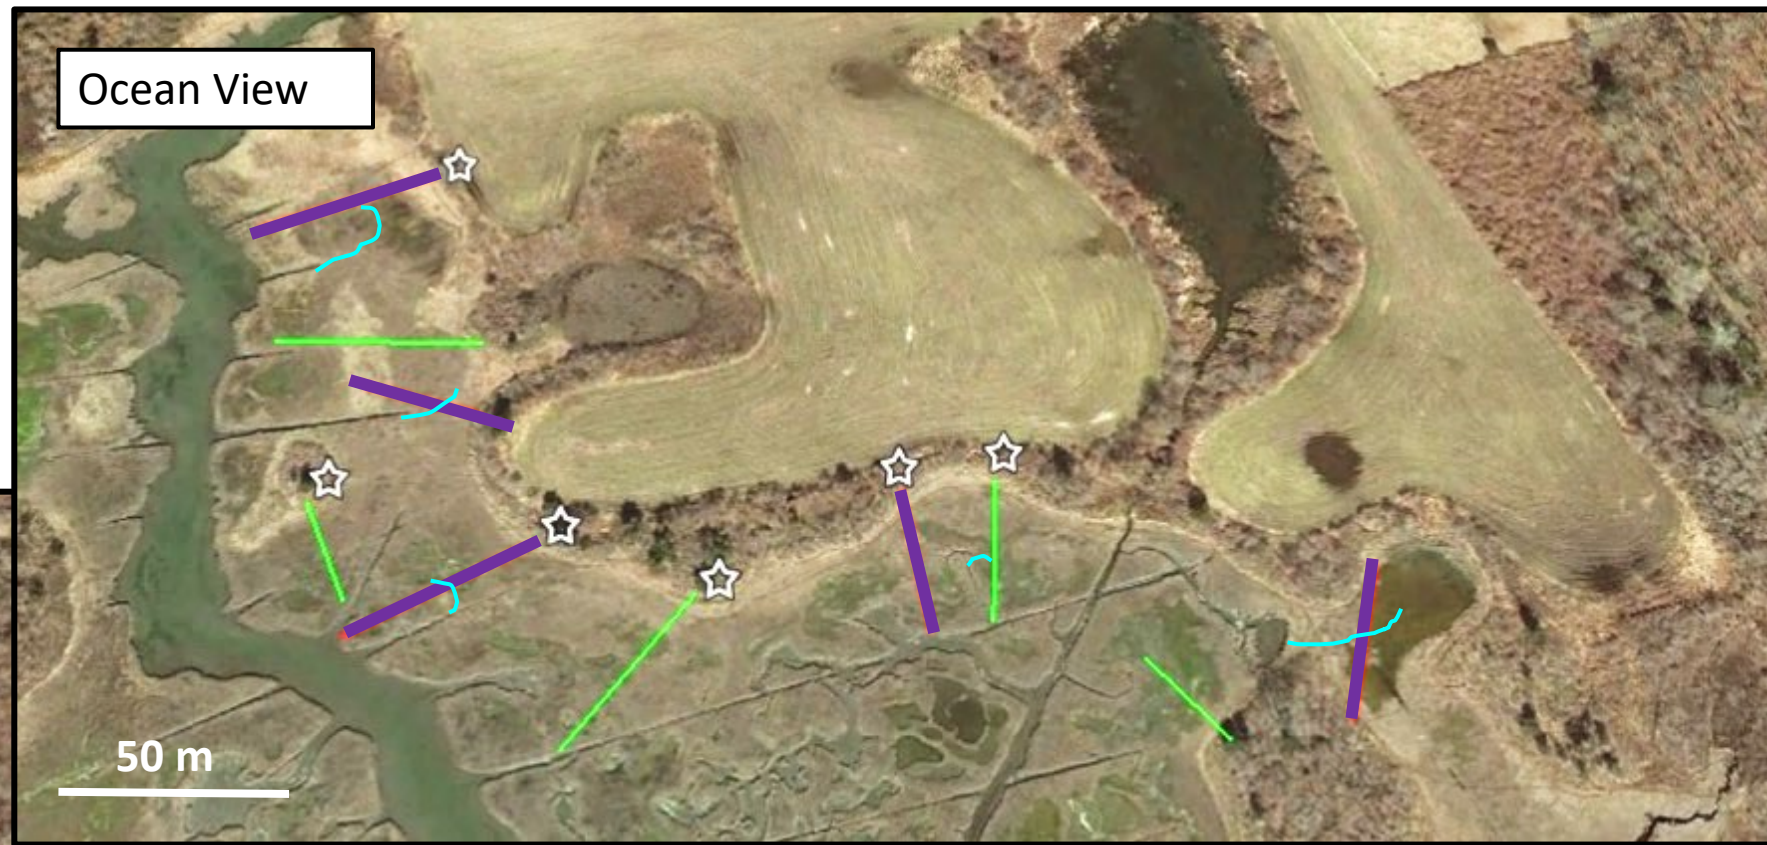
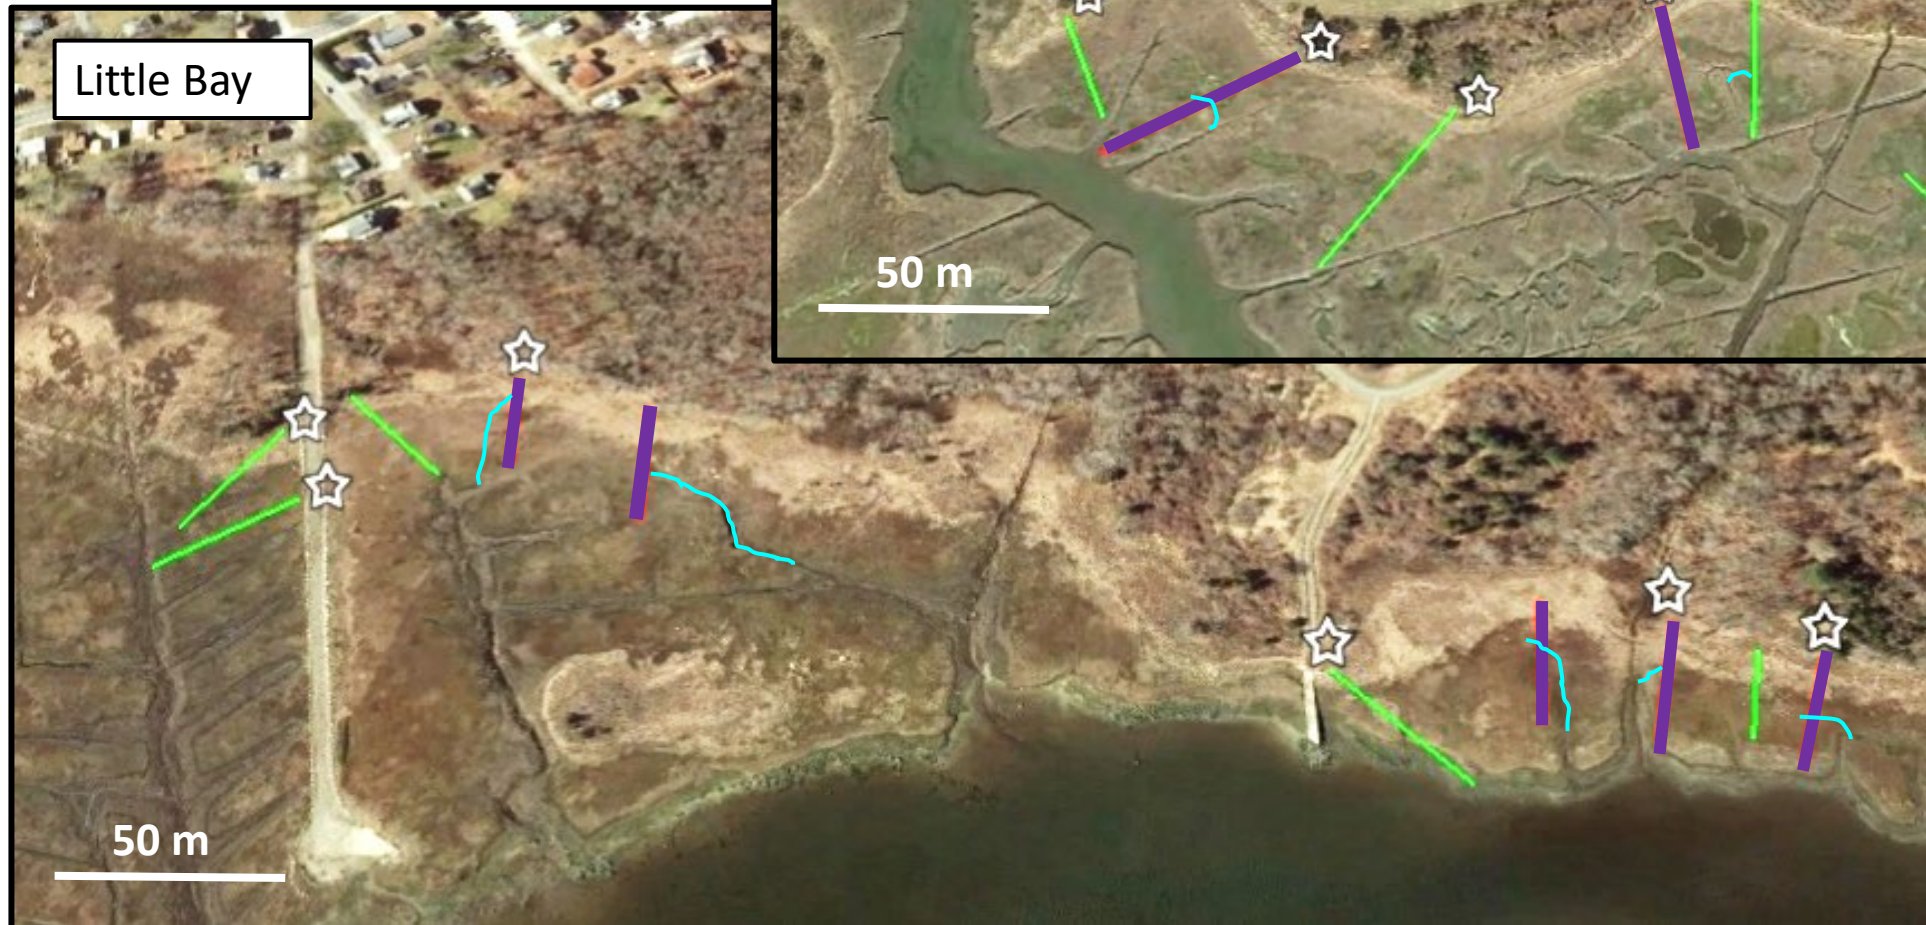
- Pre-monitoring 2020
- Runnels created Oct 2020 - Feb 2021
- Monitor through 2023 at least

- Experimental-runnel site
- Reference site
- ☆ Intensive site

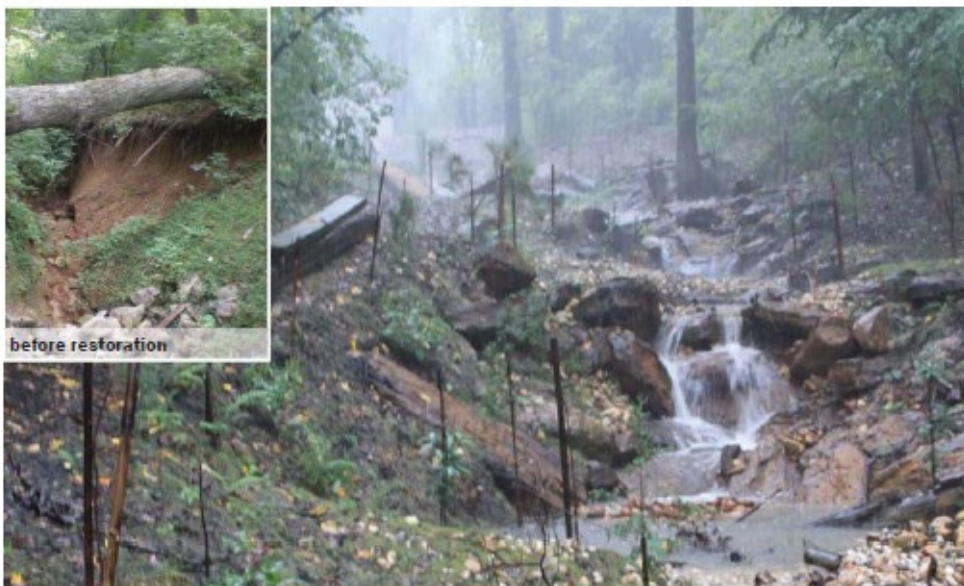
Carriage Hills Channel Restoration

Restoration provides stable surface conveyance with boulder cascades and pools during large events and conversion to groundwater flow during smaller events, attenuating discharge and treating water. Inset shows initial conditions with incised channel approximately 20 feet deep.
